Fully Automated Bacterial Monitors as tools in drinking water control, presentation of 5 different installations in Norway.

Henrik Braathen and Goran Kalaf, Colifast AS, Strandveien 33, 1366 Lysaker, hb@colifast.no

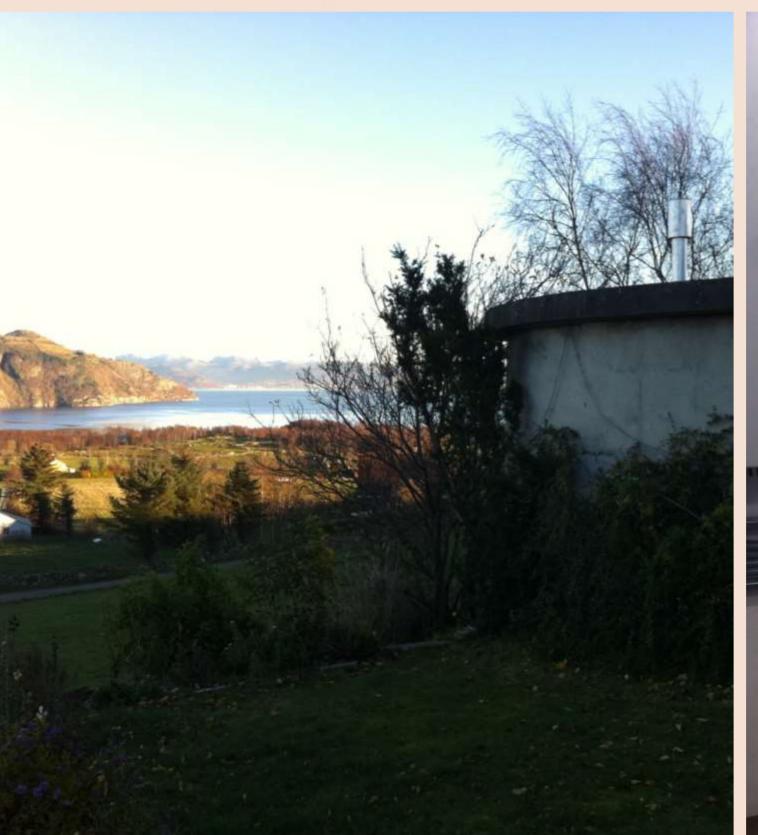
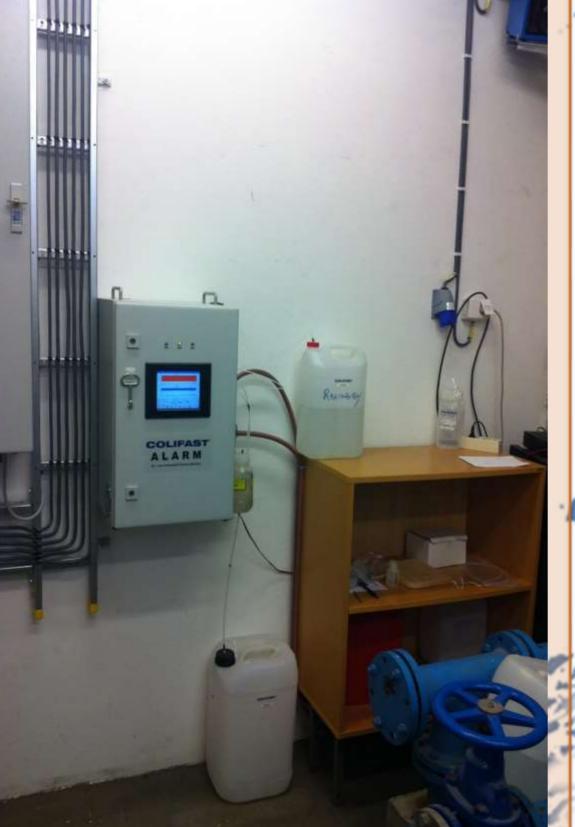
Distribution Network Monitoring. IVAR IKS, Mosterøy, Stavanger: The Colifast ALARMTM was installed in 2010. The system samples from an elevated reservoir at a remote location of the water distribution network. This reservoir is located approximately 50km from the IVAR IKS water works. Historically there has been reported fecal indicators at this site, but during the later years the water quality has been good which is shown both with the daily analysis by the Colifast system and the periodic laboratory samples. The system will alarm operators if it detects 1 or more total coliforms in 100 ml sample.

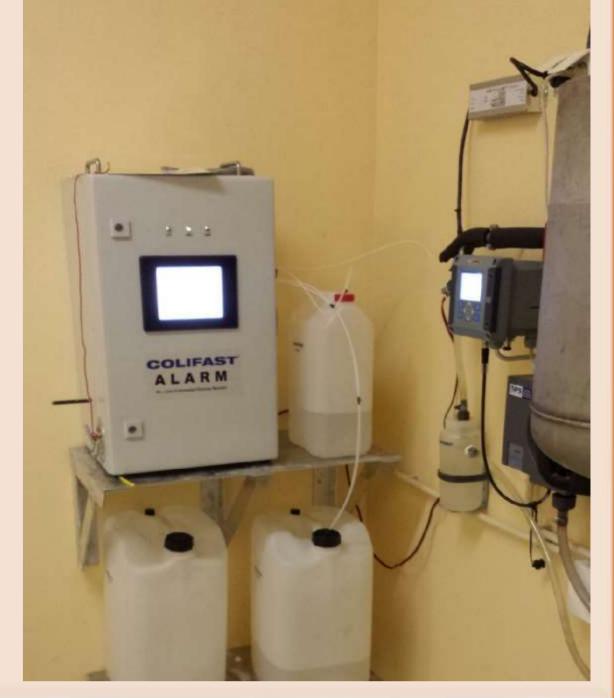
Lake (raw water) Monitoring. VIVA,
Jonsvatnet water works, Trondheim: The Colifast
ALARM™ was installed in 2012. The system
samples and analyze the raw water from lake
Jonsvatnet. It is installed at the raw water intake
station (traveling band screens) by the lake and
perform one analysis per day. The lake water has
good hygienic quality and *E.coli* is only sporadic
present and in low numbers. The instrument
generates valuable hygienic information for the
operators at the water treatment plant and gives
a better overview of the variations over time.
The system will alarm operators if it detects 1 or
more *E.coli* in 100 ml sample.

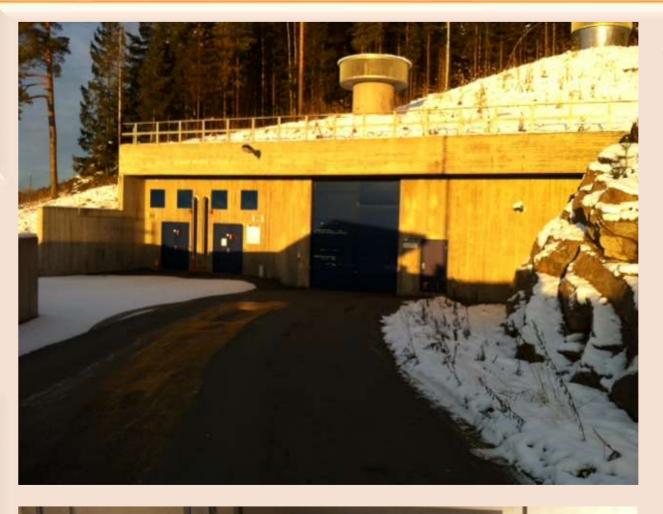
Ground Water Monitoring. GIVAS IKS, Kongsvinger: The Colifast ALARM™ was installed in 2011, at the Granli treatment plant. The system monitors the ground water which is normally used directly as drinking water without treatment. The ground water has high hygienic quality and contain no coliforms. But in some periods including flooding of the nearby river, the hygienic quality of
